Before and after pictures - of modules from the EV battery pack, during the test of the Jøni EV Fire Gun

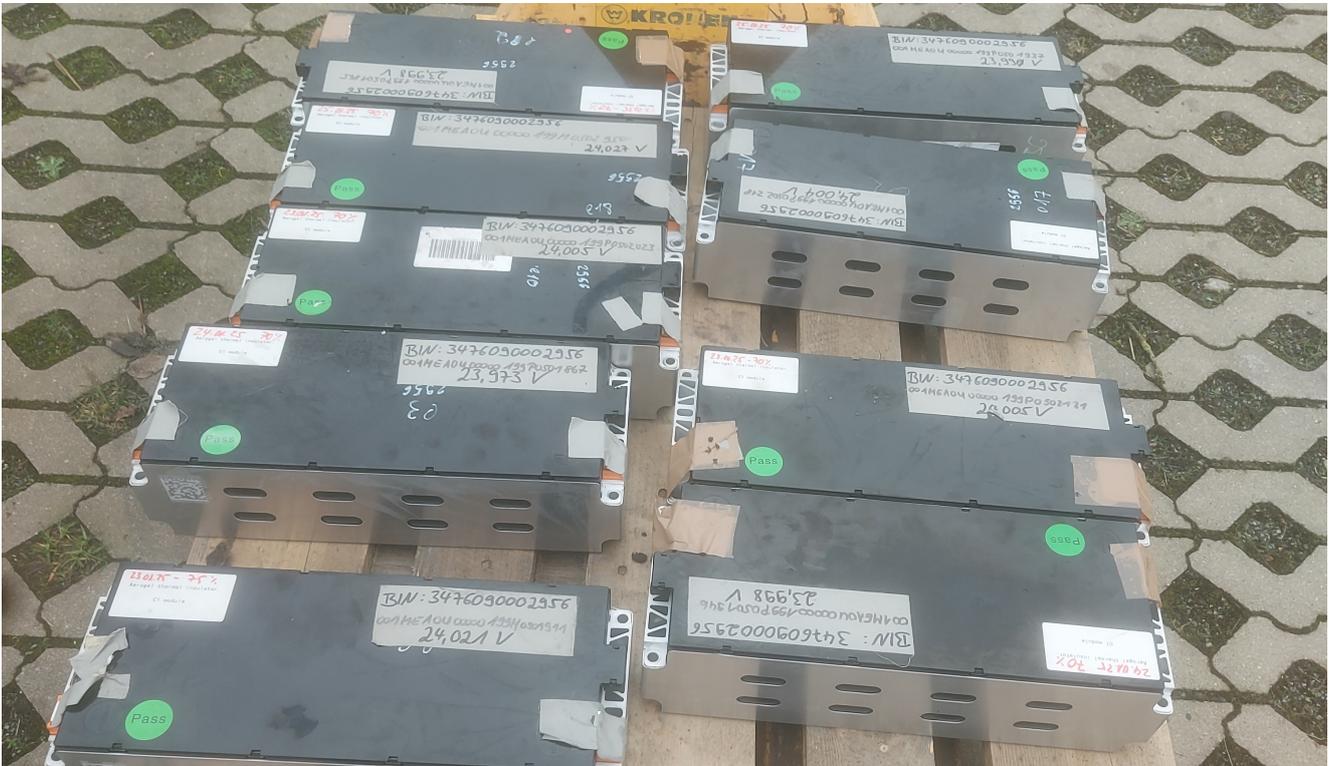
Brand new fully charged modules, from the EV battery pack to a VW ID4 - before they were provoked to burn. The fire was started with blows from a pointed axe

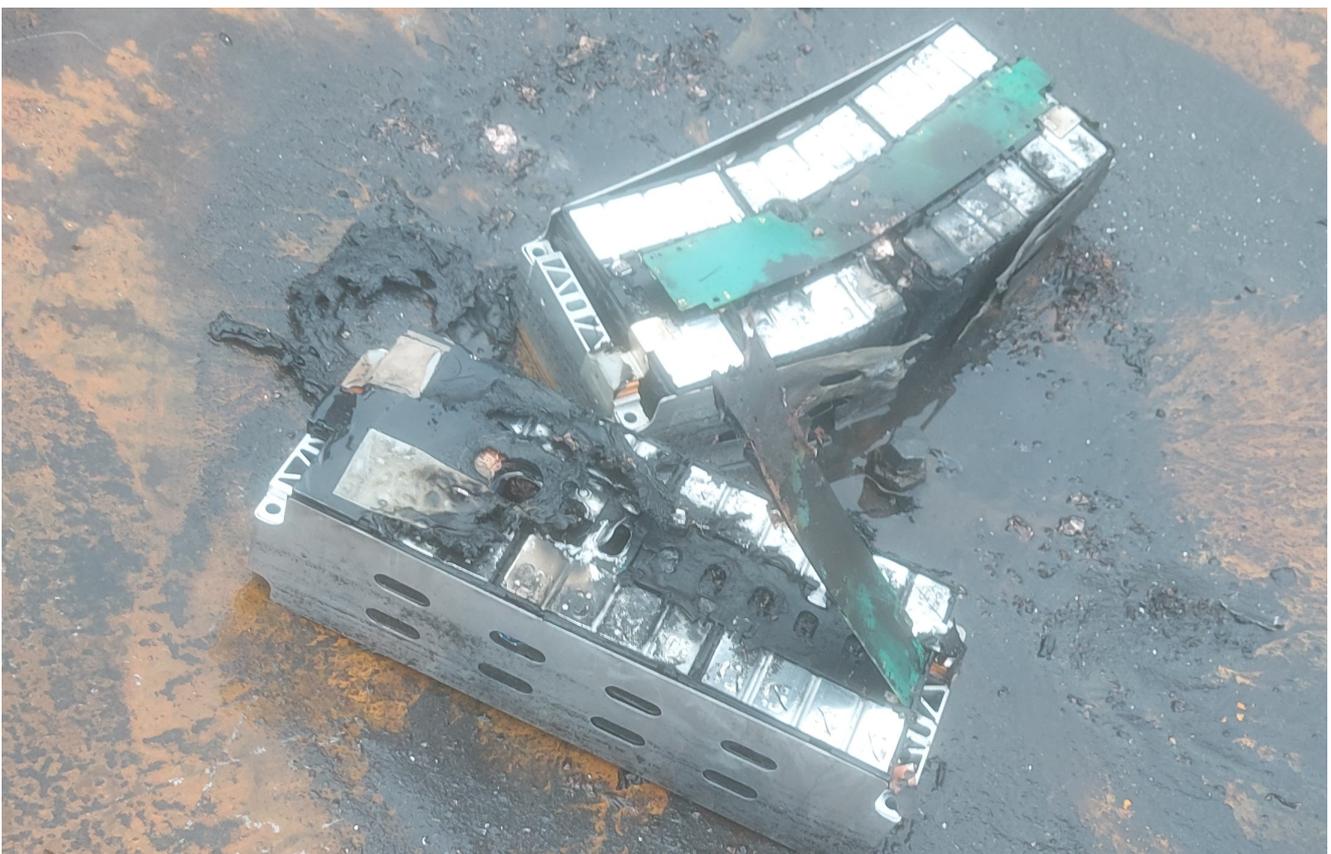
One cell in a module were provoked to catch fire - and this is what they looked like after the fire was effectively extinguished with the Jøni EV Fire Gun
